**PLASTIC FILM COATINGS FOR PROTECTION
FROM MARINE FOULING AND CORROSION**

February 1969

NAVAL CIVIL ENGINEERING LABORATORY
Port Hueneme, California

Technical Report R-612

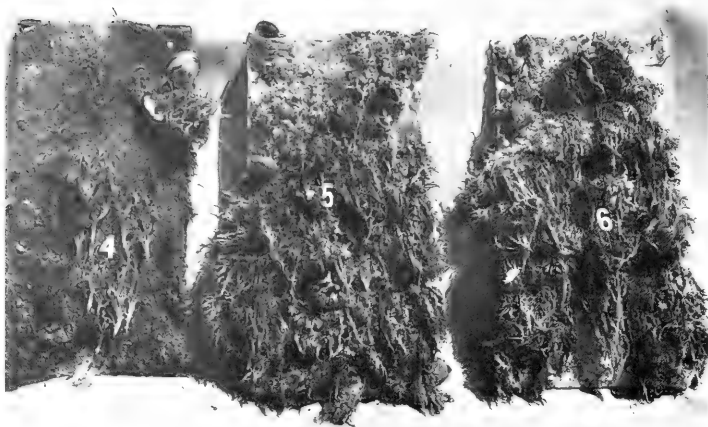
Figure 4. Biological growth over K-Monel steel panels.

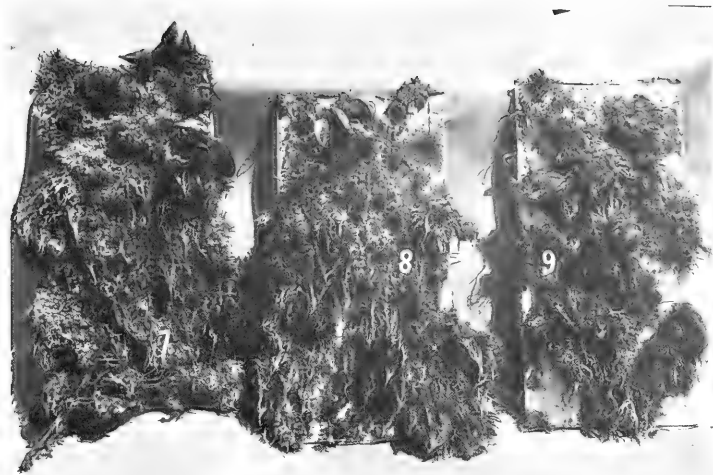
Figure 5. Biological growth over painted carbon steel panels.

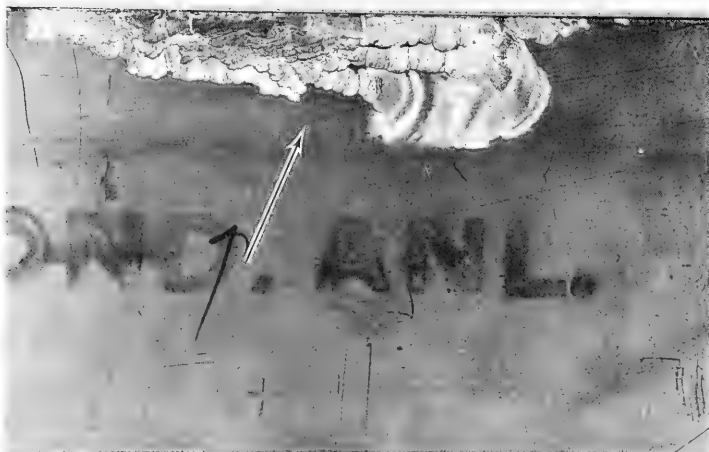
Figure 11. Close-up of a stainless steel panel, showing crevice corrosion at the edge. The corrosion occurred underneath the TFE film where seawater had leaked inside through small ruptures.

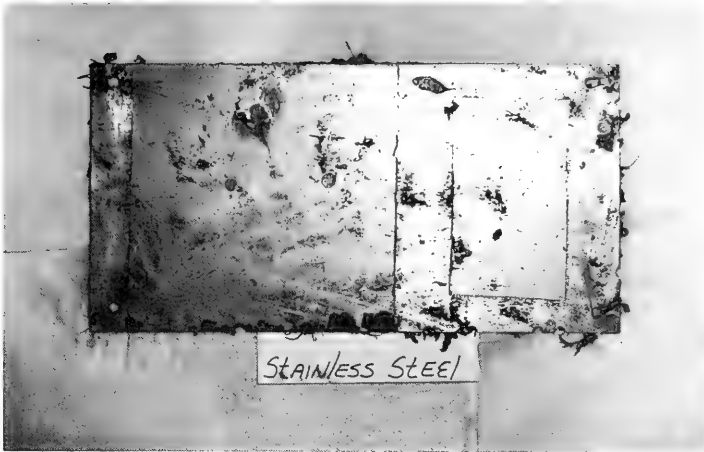
Figure 13. Stainless steel panel with saran film after biological growth had been removed with a spatula.

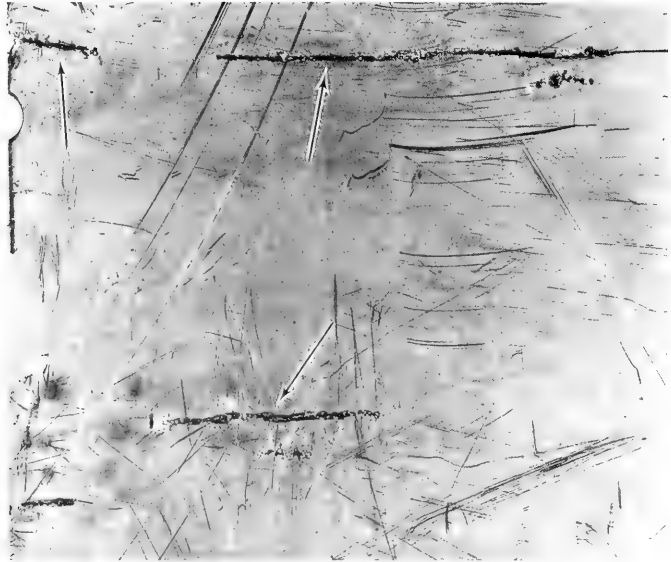
Figure 15. Close-up of stainless steel control panel showing elongated corrosion (tunnel pits). Tunnel pits were not found on protected panels.
